UNITED STATES ENVIRONMENTAL PROTECTION AGENCY

Re: Request for Information
EPA ID No.: OHD987000015

The information requested below pertains to an EPA compliance evaluation inspection ("CEI") conducted by Brenda Whitney at the A&B facility on December 17, 2015.

Photograph Log

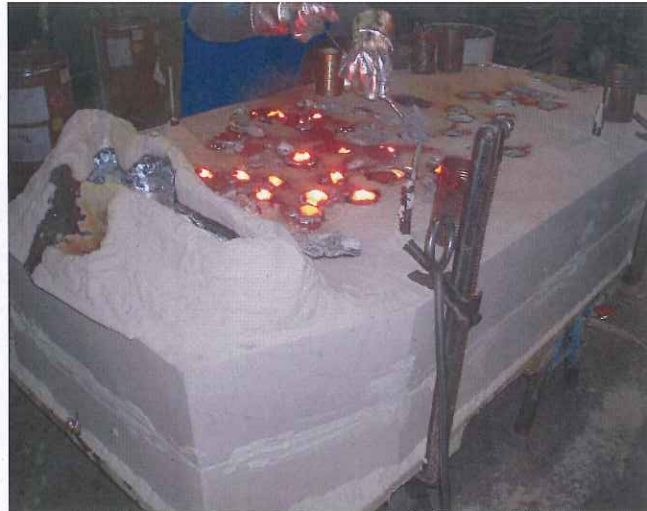
Photograph 1

An employee was applying "hot topping" to the molten metal in the risers of this mold.

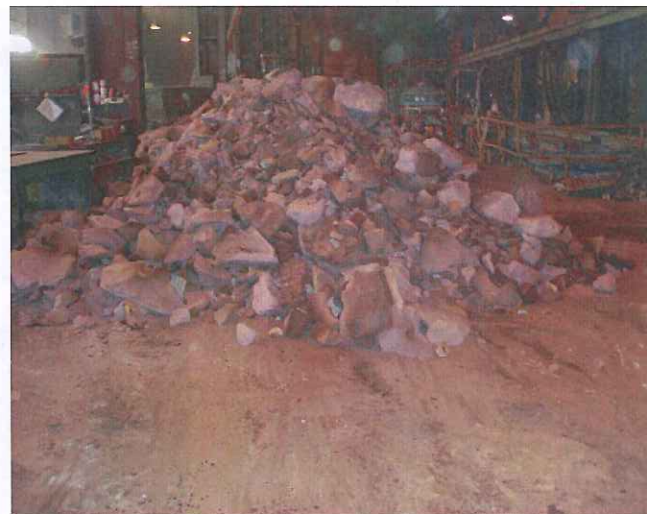
Photograph 2

In Building 1989 was a pile of sand shake-out/knock-off.

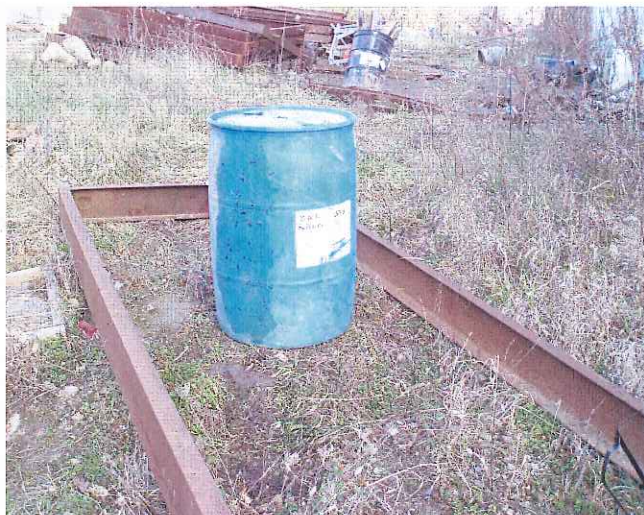
Photograph 3

One 55-gallon drum of unknown material was located outside on the property north of the foundry building.

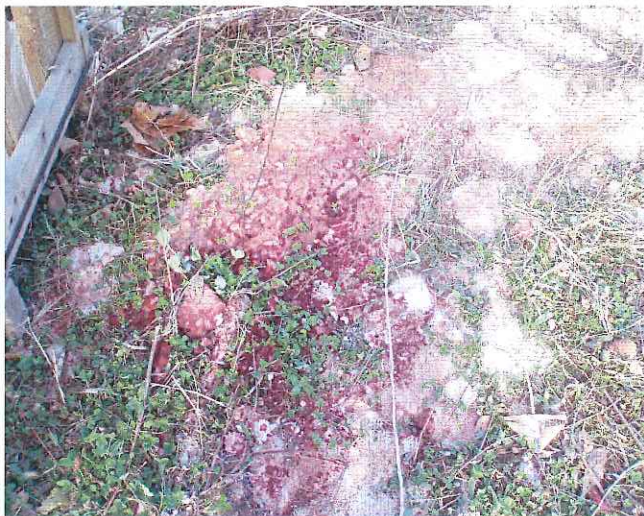
Photograph 4

A small pile of red-colored sand was located outside of the foundry near the drum identified in Photograph 3.

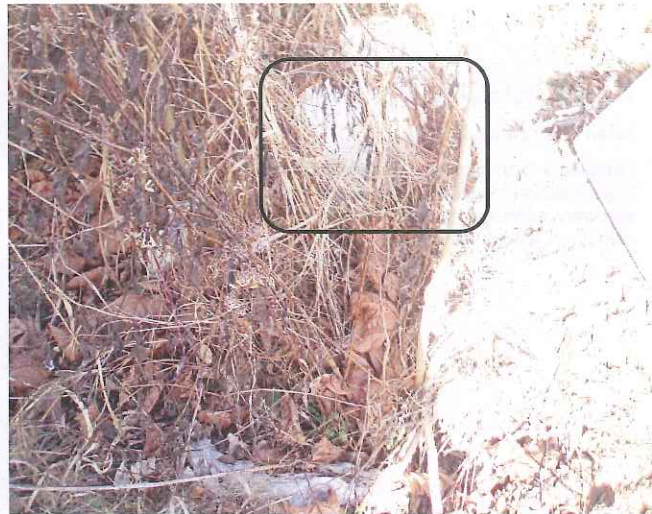
Photograph 5

Containers were observed in the brush along the fence line along the north side of the property. (Rectangle added by B. Whitney for emphasis)

3. Provide documentation supporting waste determinations for the following containers or piles of unknown spent materials which were observed during the inspection outside in the northwest portion of the facility property, unless otherwise noted:
 - a. One 55-gallon poly drum near the "1989 Building" on its side, which contained unknown liquid. This drum was righted at the time of the inspection (See Appendix A: Photograph 3).
 - b. A small pile of red-colored sand (perhaps 2 feet in diameter) located next to the drum identified in item 1.e. above.
 - c. Several containers noted in the brush along the rear fence line (See Appendix A:

- Photographs 5 and 6).
- d. Twenty-two 55-gallon drums aligned in a row in front of "Buildings C and D" that were banded together and palletized in groups of four. (See Appendix A: Photographs 7 – 9).
 - e. Old electronic equipment and other abandoned items on the ground outside (See Appendix A: Photograph 10).
 - f. One blue 55-gallon poly drum located outside near the back door of the 1989 Building (See Appendix A: Photograph 11).
 - g. One 30-gallon drum outside the back door of the 1989 Building, which appeared to be filled with oil. The oil was spilling out on top of the container (See Appendix A: Photograph 15).
 - h. Two 55-gallon drums of unknown material located near the container of oil identified in 1.k., above. (See Appendix A: Photograph 16).
 - i. One 55-gallon drum labeled as "Full" observed in the maintenance building located at the northeast side of the property.

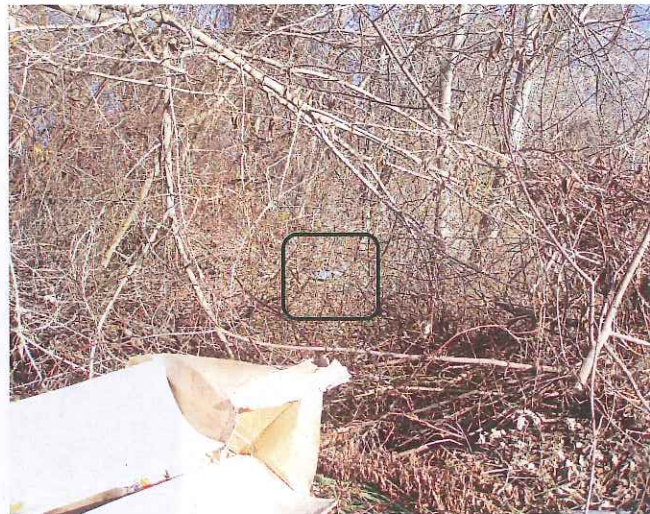
Photograph 6

One container was observed buried beneath brush near the fence line on the north side of the property. (Rectangle added by B. Whitney for emphasis).

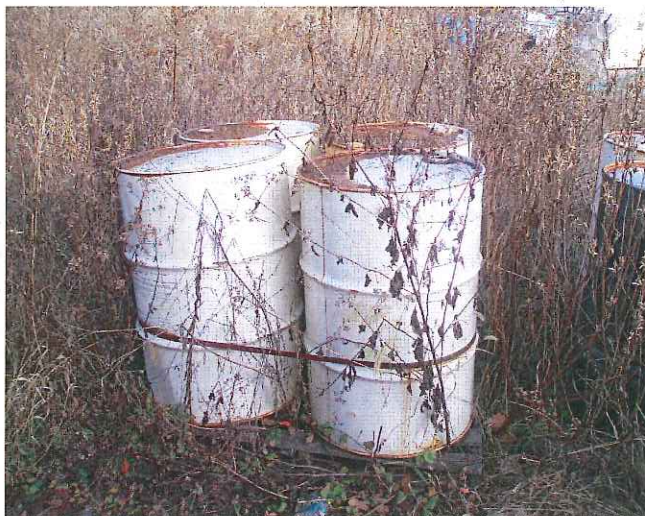
Photograph 7

Containers located in front of Buildings C and D were banded together in groups of four and were palletized. Some of these containers were bulging and rusting.

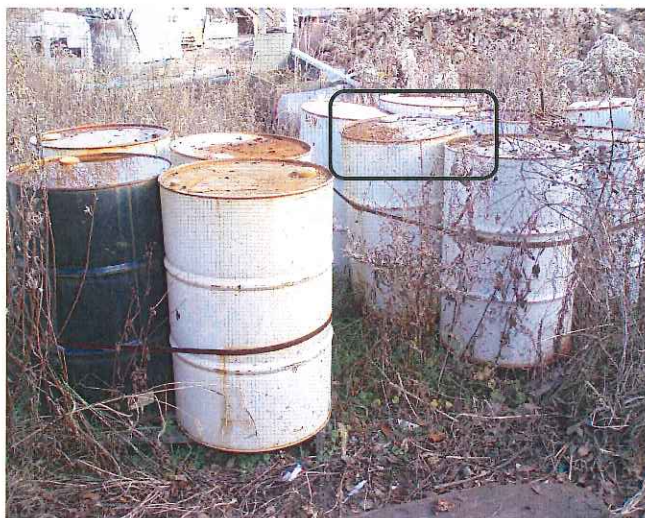
Photograph 8

Containers located in front of Buildings C and D were banded together in groups of four and were palletized. Some of these containers were bulging and were rusting. (Rectangle added by B. Whitney to emphasize bulging container).

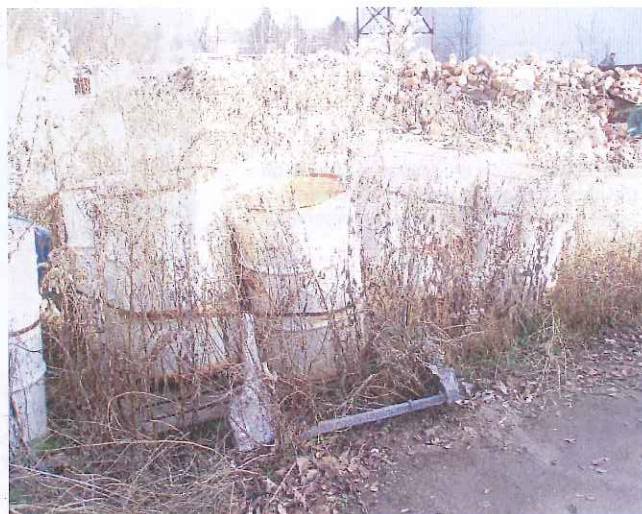
Photograph 9

Containers located in front of Buildings C and D were banded together in groups of four and were palletized. Some of these containers were bulging and were rusting.

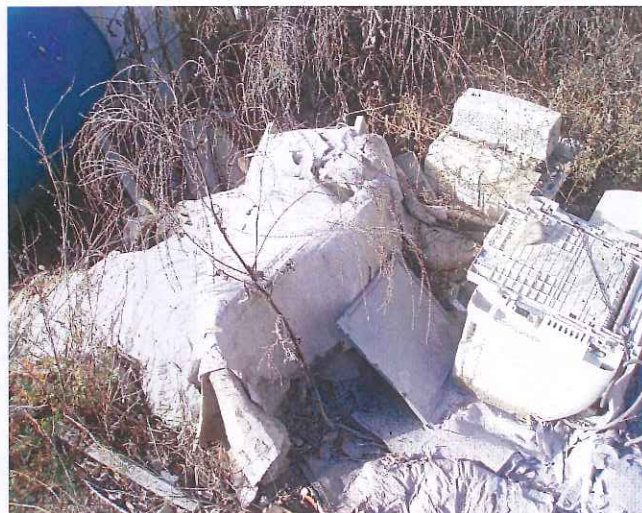
Photograph 10

Old electronic equipment were abandoned on the ground behind the containers identified in Photographs 7-9, above.

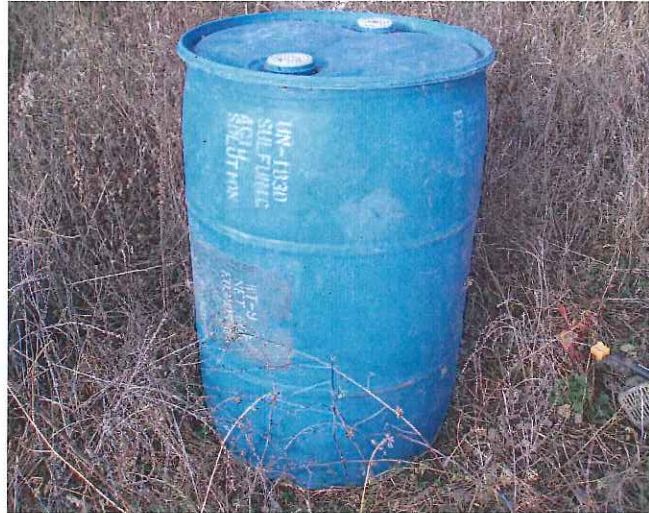
Photograph 11

One 55-gallon poly drum located outside on the north side of the property was not labeled and contained unknown material.

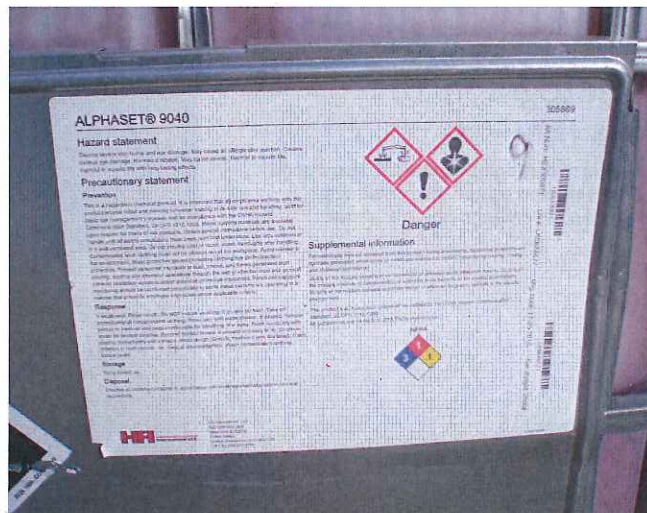
Photograph 12

This photograph shows the product label on an Alphaset tote that was stored outside of the facility.

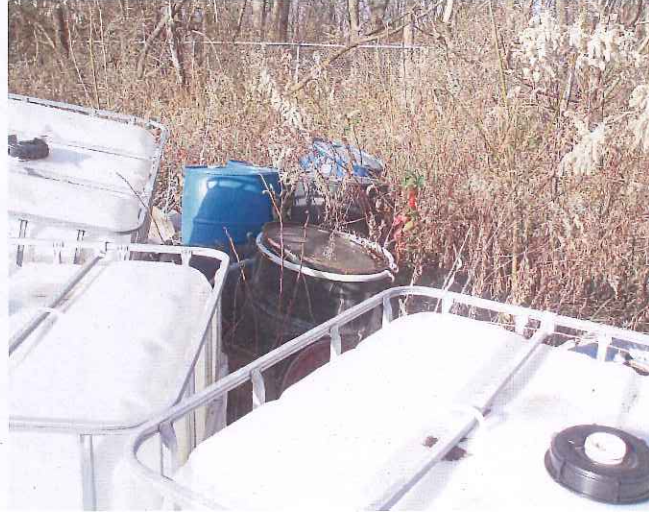
Photograph 13

Additional containers were stored outside near the fence line of the property. It was unknown at the time of the inspection if these containers held waste. The totes in the foreground are empty containers of Alphaset.

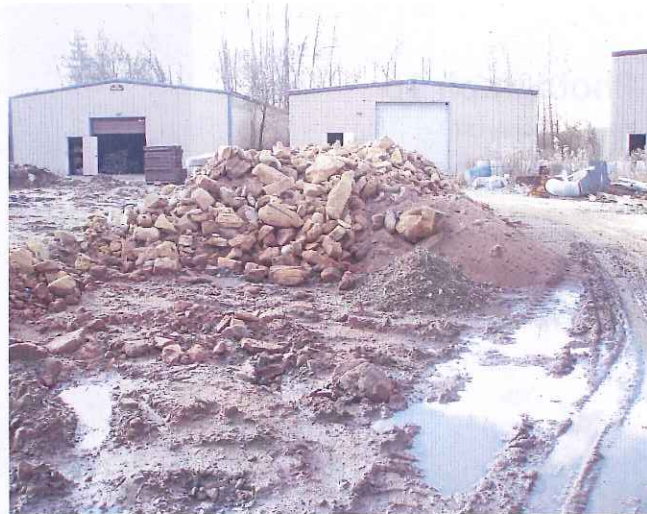
Photograph 14

Piles of shake-out/knock-off sand were accumulating outside around the property.

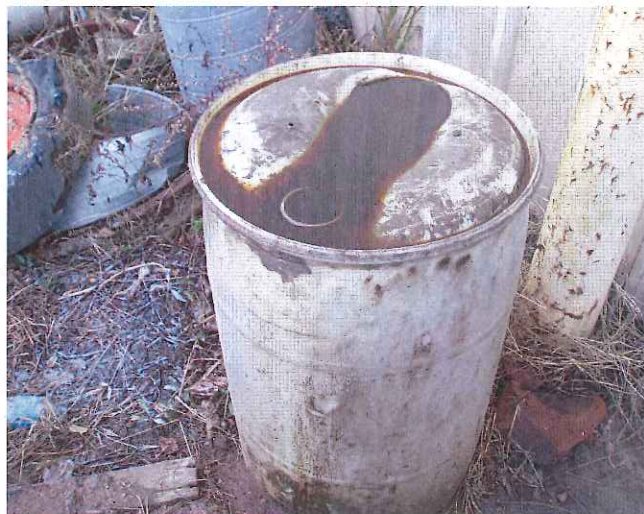
Photograph 15

One 30-gallon drum outside the back door leading into the 1989 Building appeared to be filled with oil. The oil was spilling out on top of the drum.

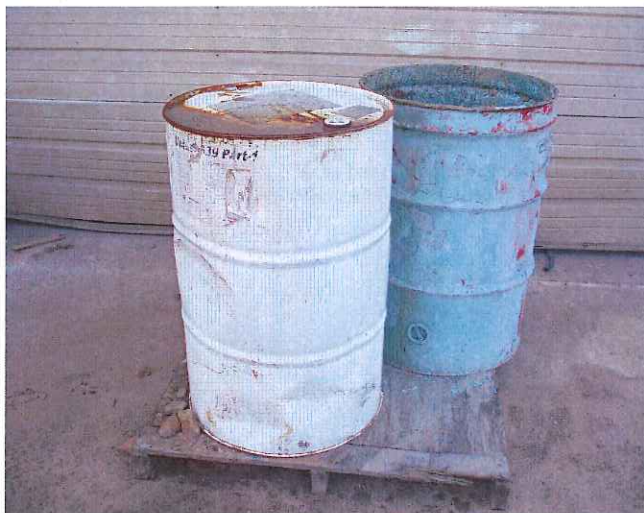
Photograph 16

Two 55-gallon drums were positioned on a pallet near the container identified in Photograph 15, above. The leftmost (white) drum contained unknown material.

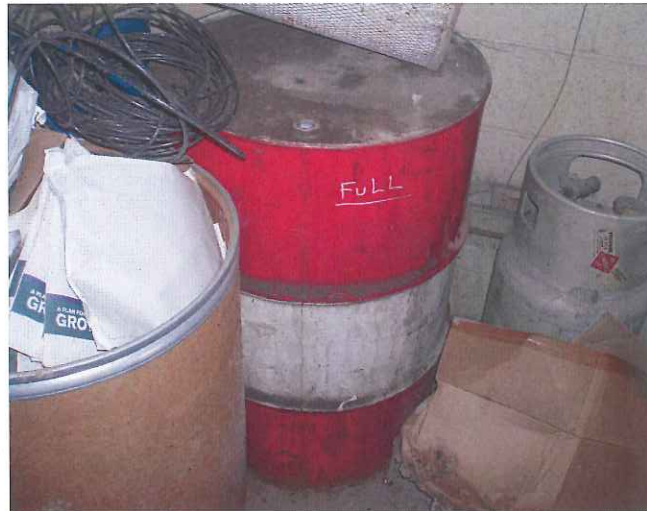
Photograph 17

One 55-gallon drum in the maintenance building in the eastern corner of the property was labeled as "Full." It was not known at the time of the inspection what was in this container.

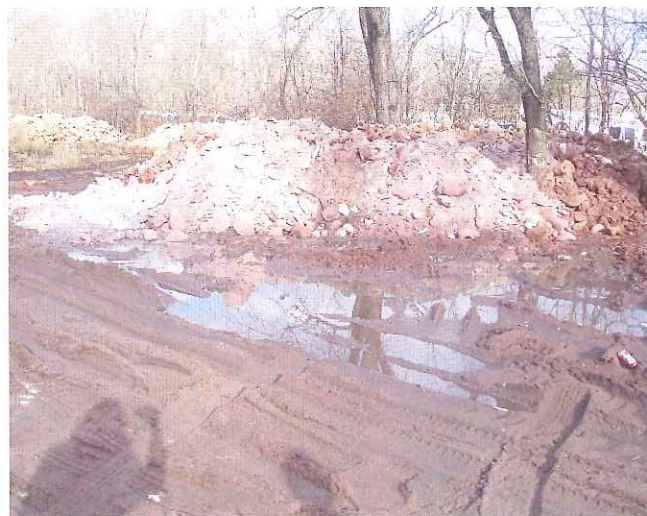
Photograph 18

Piles of shake-out/knock-off sand were accumulating outside the property.
